# Manhole Inspection Summary

Manhole # S19MM\_002MH

Insp Date: **7/3/07 11:36 AM**

**Location** Address: **1915 WINDSOR AVE**

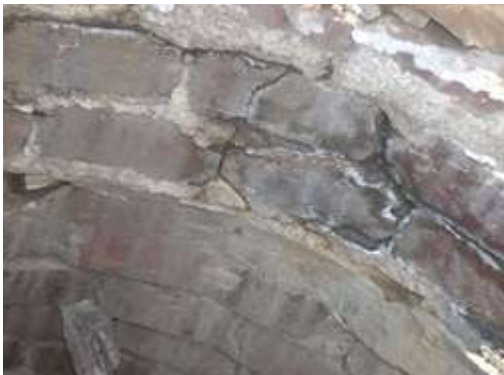
Defect 3

Condition: ☐ Sound ☒ **Cracked** ☐ Root Intrusion ☐ Loose Brick ☐ Deteriorated

CRACKED CHIMNEY

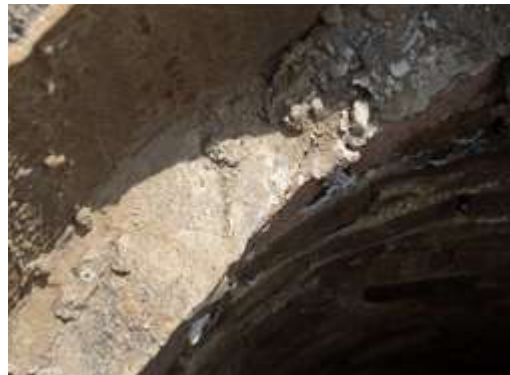
Defect 2

Offset: **3** (in.)

FRAME OFFSET

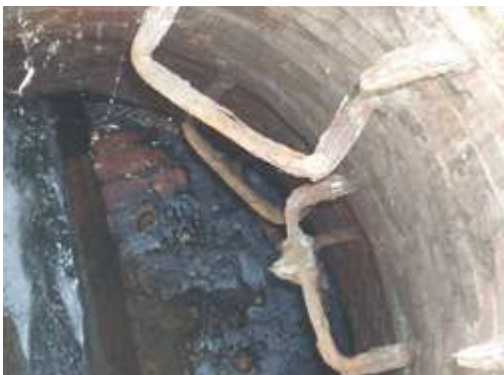
Defect 1

Count: **5** Missing: **1** ☒ **Corroded**

☒ **Evidence Of Surcharge** Depth: **3** (ft.) ☐ Active Surcharge Present

MISSING AND CORRODED STEPS,  
EVIDENCE OF SURCHARGE

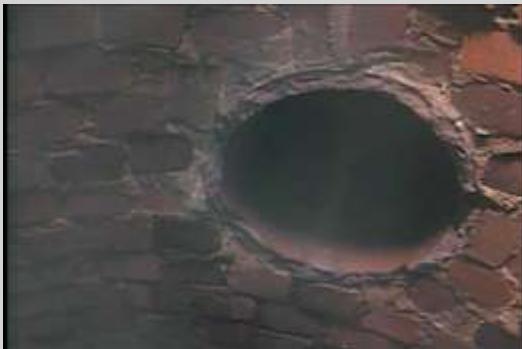
6 O'Clock Inflow

BARREL INFILTRATION

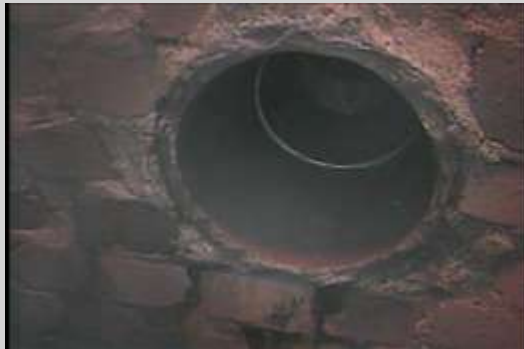
9 O'Clock Inflow

BARREL INFILTRATION

Deposits: ☐ None ☒ **Mud** ☐ Sludge ☐ Debris ☒ **Grease**

Silt Depth: **4** (in.) Deposits Extent: **Heavy**
